Contract #: 04-0120F4Cty: SF/ALA Rte: 80 PM: 13.2/13.9File #: 69.28**WELDING INSPECTION REPORT****Resident Engineer:**Pursell, Gary**Address:** 333 Burma Road**City:** Oakland, CA 94607**Report No:** WIR-003053**Date Inspected:** 04-Jun-2008**Project Name:** SAS Superstructure**OSM Arrival Time:** 1430**Prime Contractor:** American Bridge/Fluor Enterprises, a JV**OSM Departure Time:** 2230**Contractor:** Zhenhua Port Machinery Company, Ltd (ZPMC), Changxing Island **Location:** Shanghai, China

Summary of Items Observed:

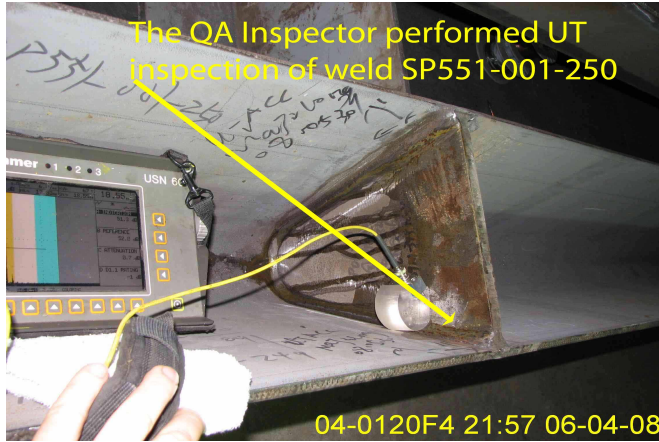
The QA Inspector performed random ultrasonic inspections of OBG closed rib Diaphragm plate weld DP-551-001-250. Items observed appear to comply with project specifications. See the TL-6027 "Ultrasonic Test Report" dated today and the photograph below for additional information.

ZPMC 'Notification of Witness Inspection' document #00484 states DP551-001-245, DP551-001-244 and several other similar welds will be ultrasonically inspected by QC Personnel starting at 1930 hours. The QA Inspector observed the original "UT Reject" markings are on these welds and the QA Inspector did not observe where ZPMC QC UT personnel had marked these welds as being "UT Acceptable". See the photo below for additional information.
